DEPARTMENT OF TRANSPORTATION**DIVISION OF ENGINEERING SERVICES**

Office of Structural Materials

Quality Assurance and Source Inspection

Contract #: 04-0120F4Cty: SF/ALA Rte: 80 PM: 13.2/13.9File #: 69.15**SOURCE INSPECTION REPORT****Resident Engineer:**Pursell, Gary**Address:** 333 Burma Road**City:** Oakland, CA 94607**Report No:** SIR-002265**Date Inspected:** 11-Jun-2010**Project Name:** SAS Superstructure**OSM Arrival Time:** 700**Prime Contractor:** American Bridge/Fluor Enterprises, a JV**OSM Departure Time:** 1900**Contractor:** Zhenhua Port Machinery Company, Ltd (ZPMC), Changxing Island **Location:** Shanghai, China**Quality Control Contact:** Mr. Don Walton**Quality Control Present:** Yes No**Material transfer:** Yes No N/A**Sampled Items:** Yes No N/A**Stock Transfer:** Yes No N/A**OK to Cut:** Yes No N/A**Rebar Test Witness:** Yes No N/A**Delayed/Cancelled:** Yes No N/A**Other:** Coatings Inspection**Bridge No:** 34-0006**Component:** See Below**Bid Item:** 77, 78, 79**Lot No:** B #204**Summary of Items Observed:**

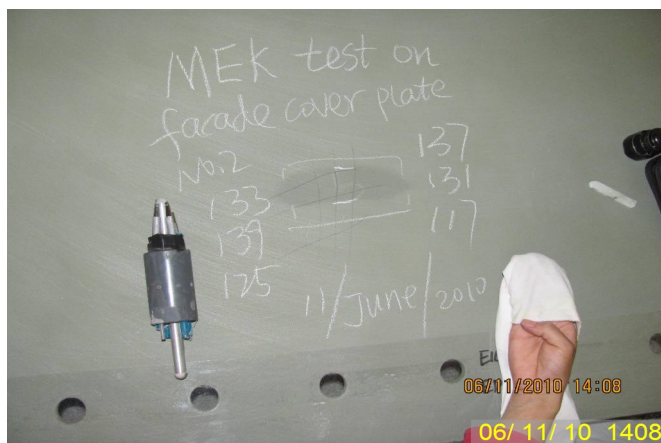
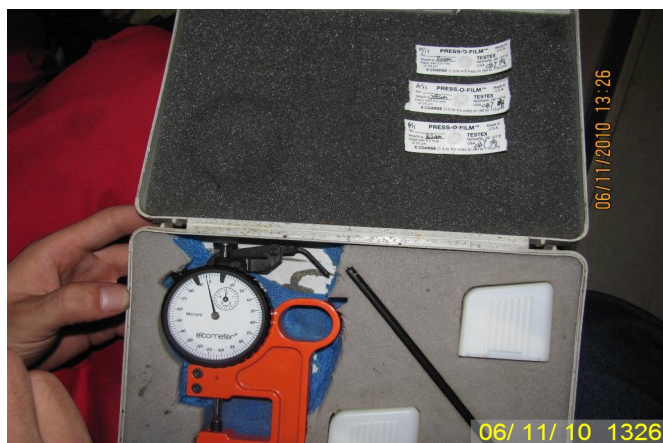
1. An inspection was requested on the Cross beam (CB7) internal surface ,for Blasting inspection, vide request no. 3384 at Blasting shop 1. This Caltrans inspector observed, ABF inspectors Mr. Vince and Mr. Yui performing said inspection check . It was observed that, these external surfaces were rejected by ABF Inspectors for grinding points and Low profile in some of the areas. The ambient conditions were monitored and is 5 deg. above due point and the relative humidity found to be 76.3% which is acceptable as per contract documents. This Cross beam again offered for inspection vide notification no. 3386, 3388 and 3390. The notification nos 3386 and 3388 found rejected by ABF inspectors for low profile and non attending of Grinding points. The profile was measured and found to be in the range of 78 to 84 microns. This cross beam finally accepted by ABF inspector Mr. Sun. X1 Residual chlorides test have been conducted by ZPMC inspectors and the result found to be 10 us/cm. The result of Residual chlorides test and Profile test found to be acceptable as per contract documents. International protective coatings technical service representative Mr. Li peng was found present during the course of this inspection process. Photograph showing results of profile test is attached with this report.
